A Defect Attorney's Dream  
By Jim Turner, CRI  
Jim Turner Building Inspections & Consulting  
Upland, CA.

**Subject Property:** 2800 square foot A-frame style residence, built in 2003, located in Big Bear, California, a mountain resort community located approximately 90 miles East of Los Angeles.

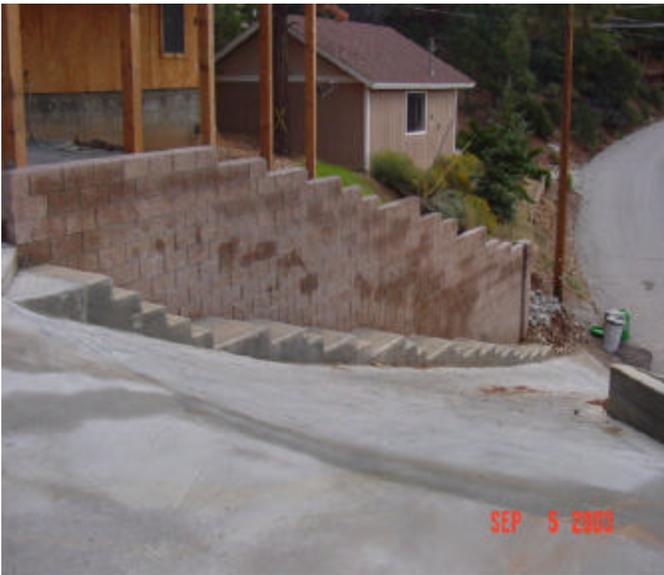
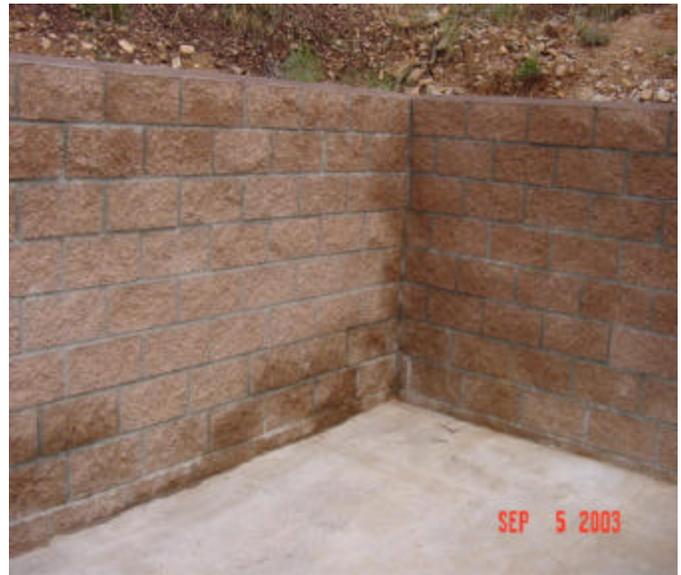
Evidence of water intrusion through the retaining wall surfaces was observed. The retaining walls were not provided with weep holes for drainage nor were evidence of a sub-surface drainage system observed.

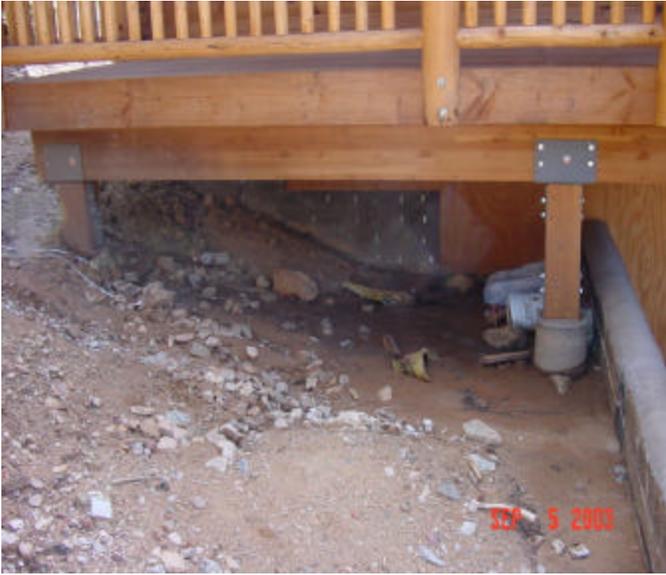
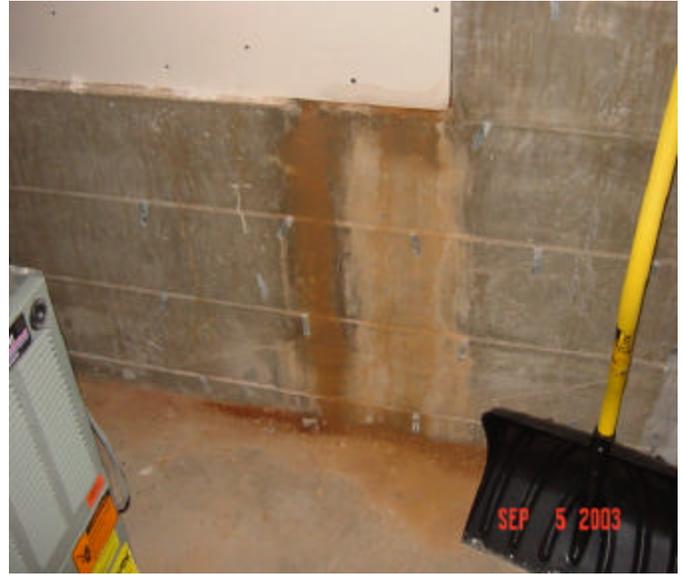
Evidence of improper grading of the soil and inadequate drainage provisions around the perimeter of the structure was observed. Water accumulation and penetration into the basement was observed. Also, an unexplained water leak at the garage foundation was observed.

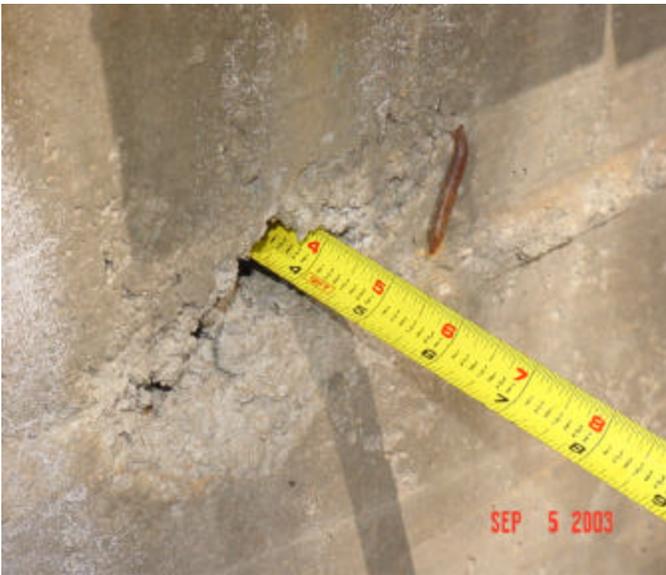
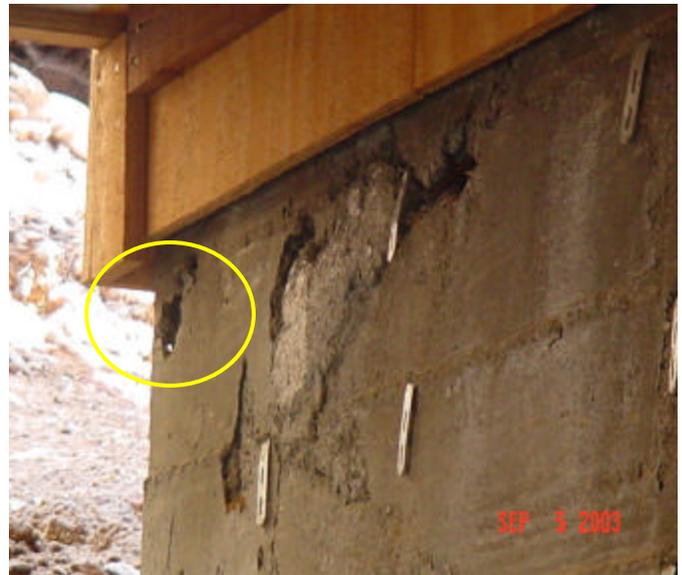
Evidence of holes and pockets at several locations in the concrete foundation surface was observed. This may have been due to improper, or a lack of, vibrating of the concrete in the forms during application.

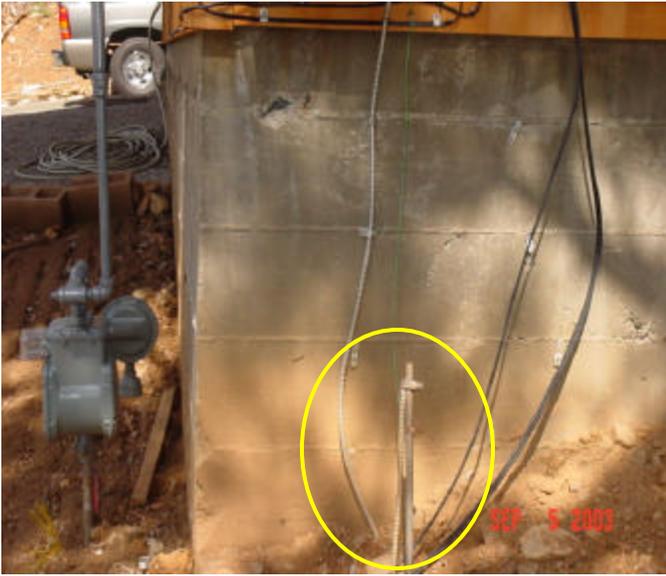
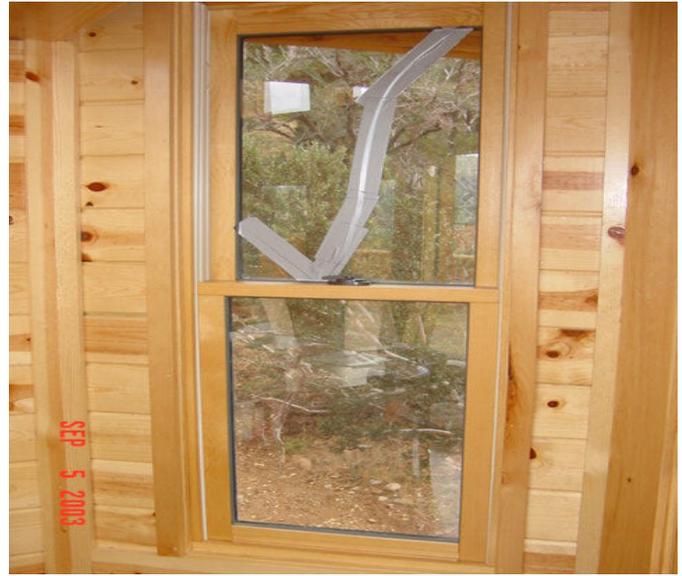
The client reported that during a recent storm, lightning had struck the “lightning rod” located at the exterior of the structure below the dining room window. The result of this event was a cracked window in the dining room. Upon examination of the exterior, it was determined that the “lightning rod” was in fact a section of rebar, exposed 2-3 feet above the soil, used as the grounding rod for the electrical system.

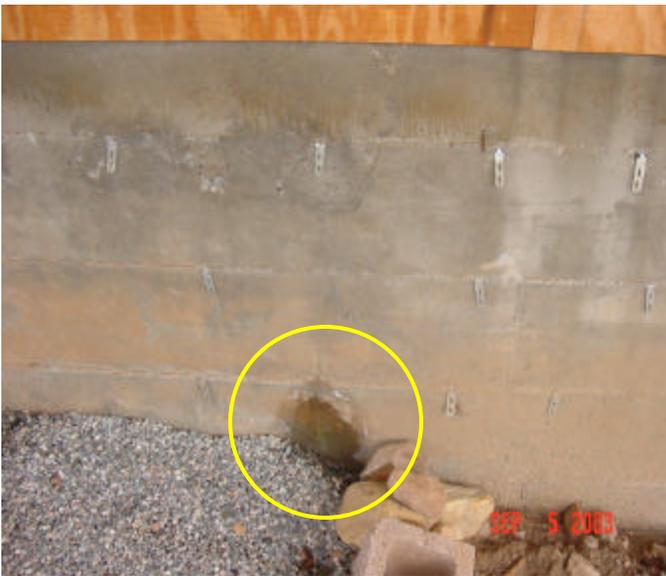
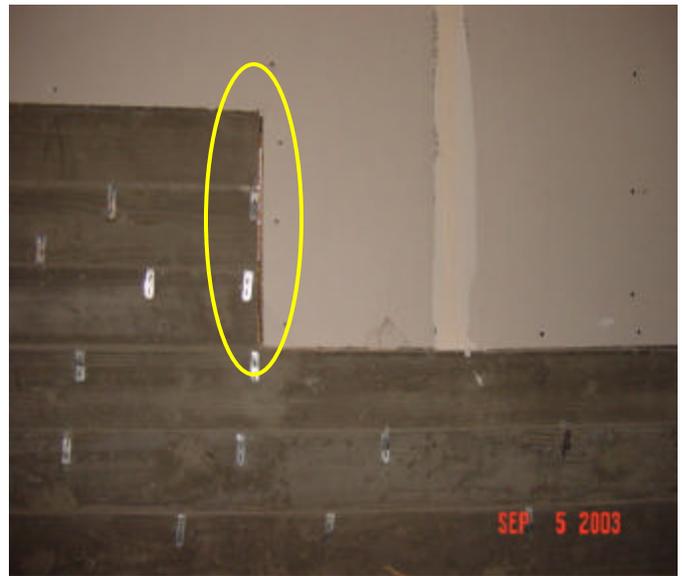
An unexplained water leak at the garage foundation and a noticeable gap at the sill plate in the basement, with direct exposure to the exterior, were observed.
