A Study of Asphalt Composition Roofing Defects

By; Jim Turner, CRI

Jim Turner Building Inspections & Consulting

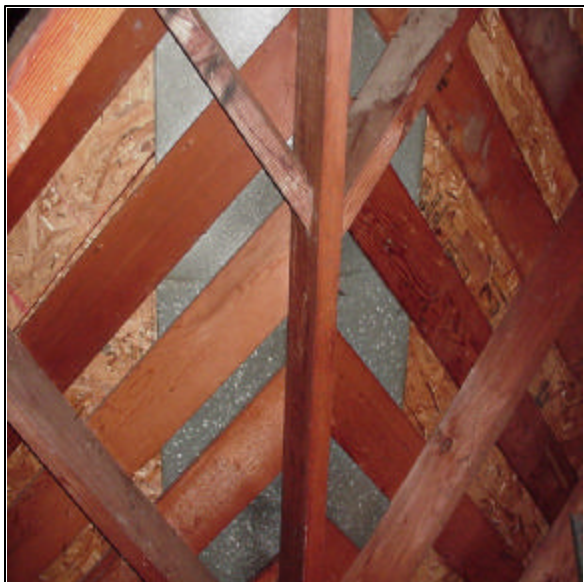
As part of my usual preliminary interview with the buyer's Realtor and the homeowner, I discovered that the roof had been replaced a month before the property was put on the market. At first glance, after climbing the ladder to the front roof deck, the roof materials appeared to have been installed in a professional manner. However, once I started walking the deck, and especially after cresting the ridge and viewing the rear roof deck, it became apparent that my initial impressions were wrong.

When walking the roof, I noticed that the deck was exceptionally "bouncy". Now, I'm not what you would call a featherweight, but the roof deck should not react like a trampoline regardless of a person's size. The deck sheathing was literally slapping the roof rafters throughout the roof. Upon additional examination of the attic and garage I discovered that the roof sheathing was nailed in the corners only. The metal valleys from the previous wood shake roof had not been removed and the sheathing was laid on top of them, again without any fasteners. My suspicions were beginning to rise that this roof may not have been inspected by the local building department.

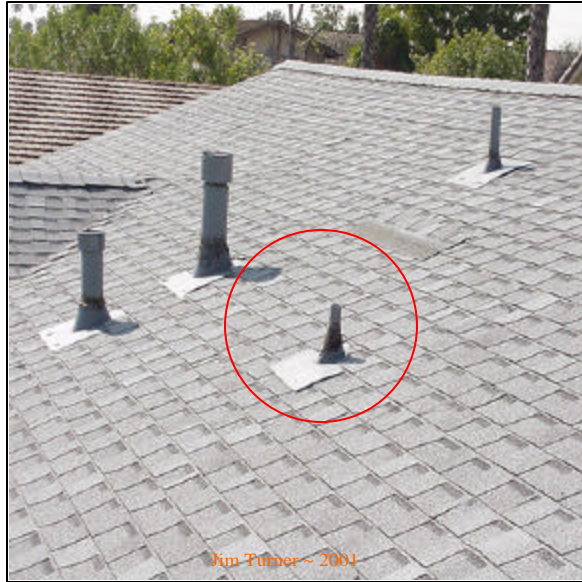
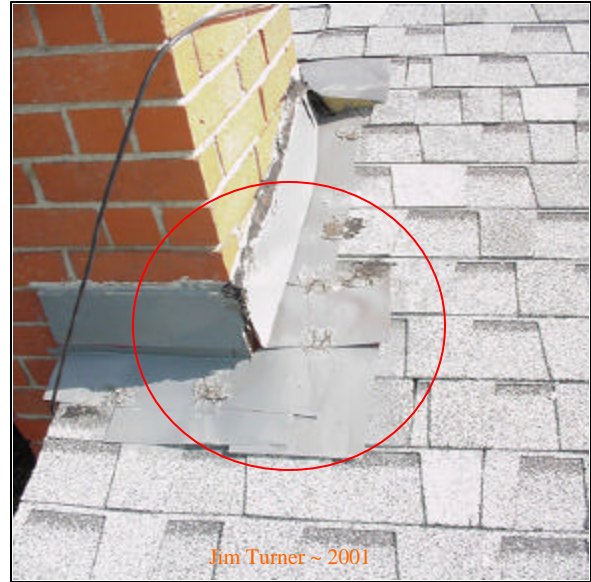
The rear portion of the roof revealed even more surprises. From the ridge I noticed that all of the plumbing penetration flashings were improperly installed over the shingles and sealed with roofing cement at the edges. The chimney counter flashings were installed in a similar manner along with nails driven directly through the step flashings and into the shingles.

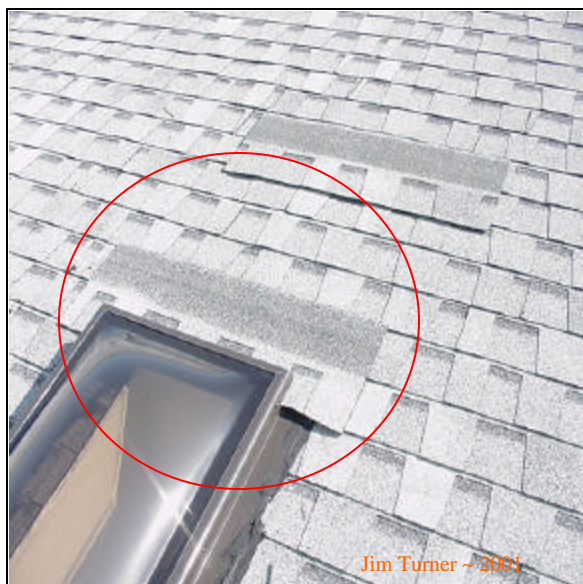
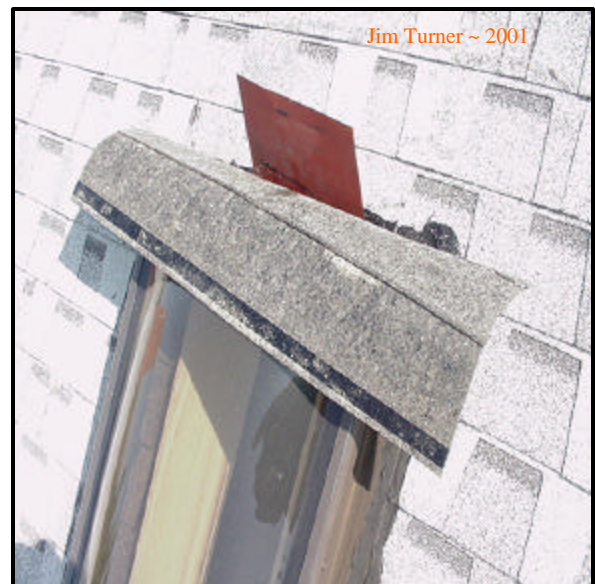
The rear roof deck also contained several skylights. Here is where the installation conditions became *very* interesting. The skylights were installed as an addition during the re-roof and were not an original component of the structure. I noticed a curious anomaly where a shingle was laid on the roof at the top of each skylight. After lifting one of the shingles, it became obvious that the installer intended the shingle to act as an impromptu flashing component.

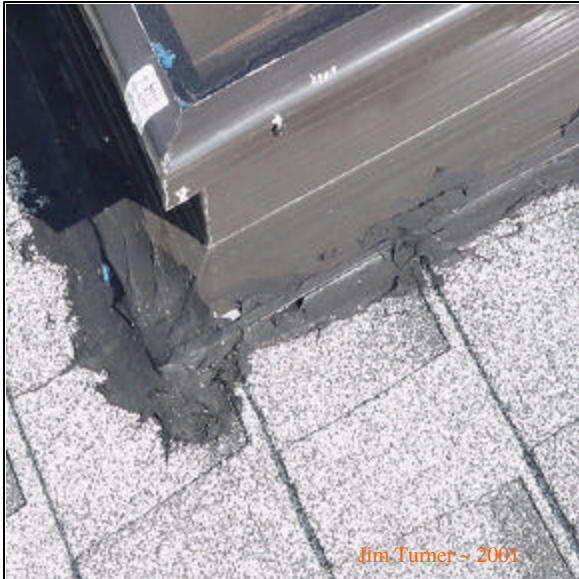
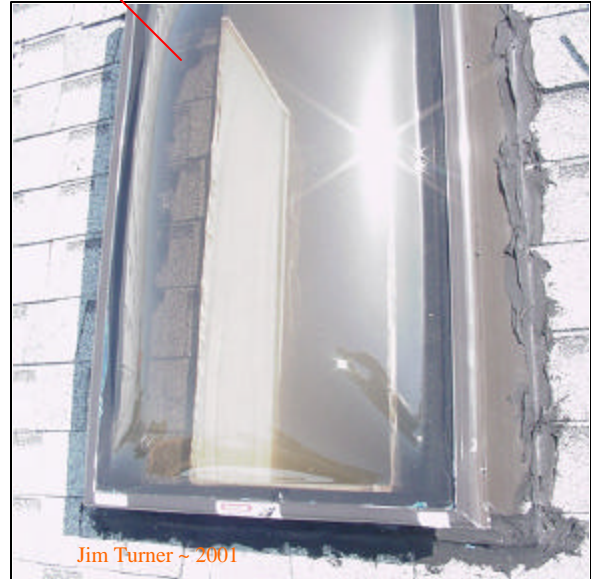
Of course the skylights were not secured to any available framing or the roof deck. The installer had cut holes into the roof deck, placed the skylights on the shingles and sealed them in place with roofing cement. But the real surprise came after a closer examination of the skylights, where I discovered that the skylight openings were 6 inches narrower on each side than the skylights' inside dimensions and were not provided with a support frame. They could literally be lifted off the roof deck.
