A Study of Asphalt Composition Roofing Defects

By; Jim Turner, CRI

Jim Turner Building Inspections & Consulting

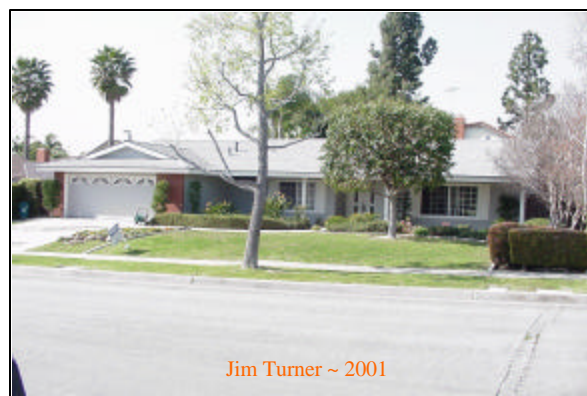
The subject structure was a single family residence built in the mid 1960's with an approximately 5:12 pitch roof deck equipped with a dimensional asphalt composition shingle application that was installed within the 1 month period prior to the home inspection. When I arrived, my first impression was that it appeared to be a well cared for property. I usually rely on my "curb feelers" to give me some sense of what an inspection is going to be like. Unfortunately on this day they failed me. The inspection proceeded uneventfully until I climbed on the roof. It was then that I realized that something was terribly wrong.

As part of my usual preliminary interview with the buyer's Realtor and the homeowner, I discovered that the roof had been replaced a month before the property was put on the market. At first glance, after climbing the ladder to the front roof deck, the roof materials appeared to have been installed in a professional manner. However, once I started walking the deck, and especially after cresting the ridge and viewing the rear roof deck, it became apparent that my initial impressions were wrong.
